7.3.0 Water Hammer At San Onofre

7.3.3 San Onofre Water Hammer Incident

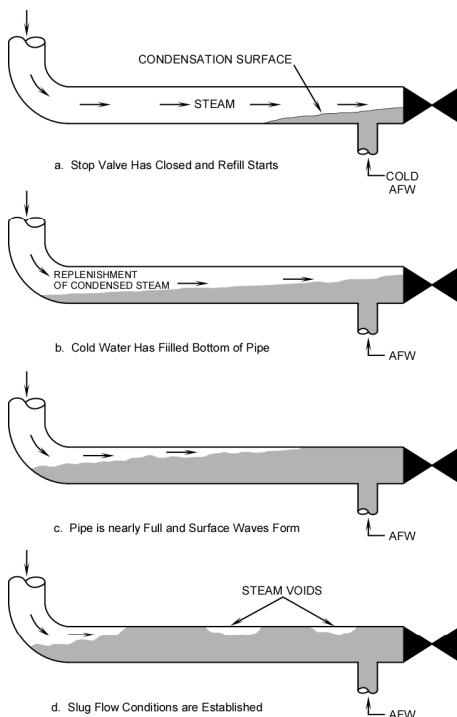
Figure 7.3-1 Filling of a Voided Feedwater Line

2. “Condensation-induced water hammer” results when cold water (such as auxiliary feedwater) comes in contact with steam. Conditions conducive to this type of water hammer are an abundant steam source and a long empty horizontal pipe run being refilled slowly with cold water. The cold water draws energy from the steam, with the rate of energy transfer being governed by local flow conditions. As the steam condenses, additional steam will flow countercurrent to the cold water, and as the pipe fills up (i.e., the void decreases) the steam velocity increases, setting up waves on the surface of the water, eventually entraining water and causing slug flow. Slug flow entraps steam pockets and promotes significant heat transfer between the steam and colder water. Figure 7.3-1 illustrates in simplified form the flow conditions which would

come about during the refilling of a voided horizontal feedwater line. Once slug flow conditions commence, a steam pocket will suddenly condense, creating a localized depressurization instantaneously. The resulting pressure imbalance across the slug (approximately 700 psi at SONGS-1) causes the slug to accelerate away from the source of pressure and toward the region of condensation.

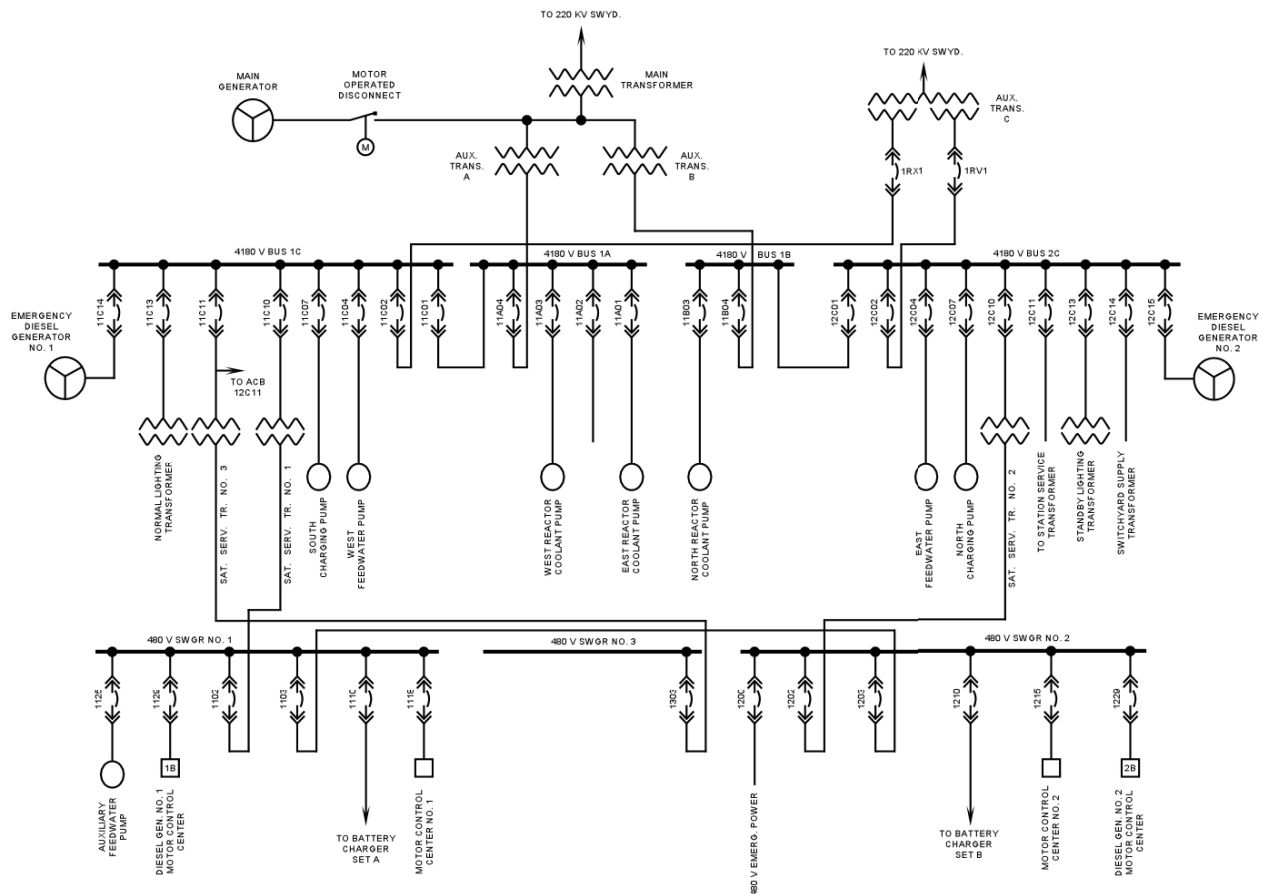
Figure 7.3-2 San Onofre Electrical System

At 4:51 a.m. on November 21, 1985, with the plant operating at 60 percent power, a ground fault was detected by protective relays associated with a transformer which was supplying power to one of two safety-related 4160-V electrical buses (see Figure 7.3-2). The resulting isolation of the transformer caused the safety-related bus to de-energize and tripped all feedwater and condensate pumps on the east side of the plant. The pumps on the west side of the plant were unaffected, since their power was supplied from another bus. The continued operation of the west feedwater and condensate pumps, in combination with the failure of the east feedwater pump discharge check valve to close, resulted in the overpressurization and rupture of an east-side flash evaporator low pressure heater unit. The operators, as required by emergency procedures dealing with electrical systems, tripped the reactor and turbine-generator. As a result, the plant experienced its first complete loss of steam generator feedwater and in-plant ac electrical power since it began operation.

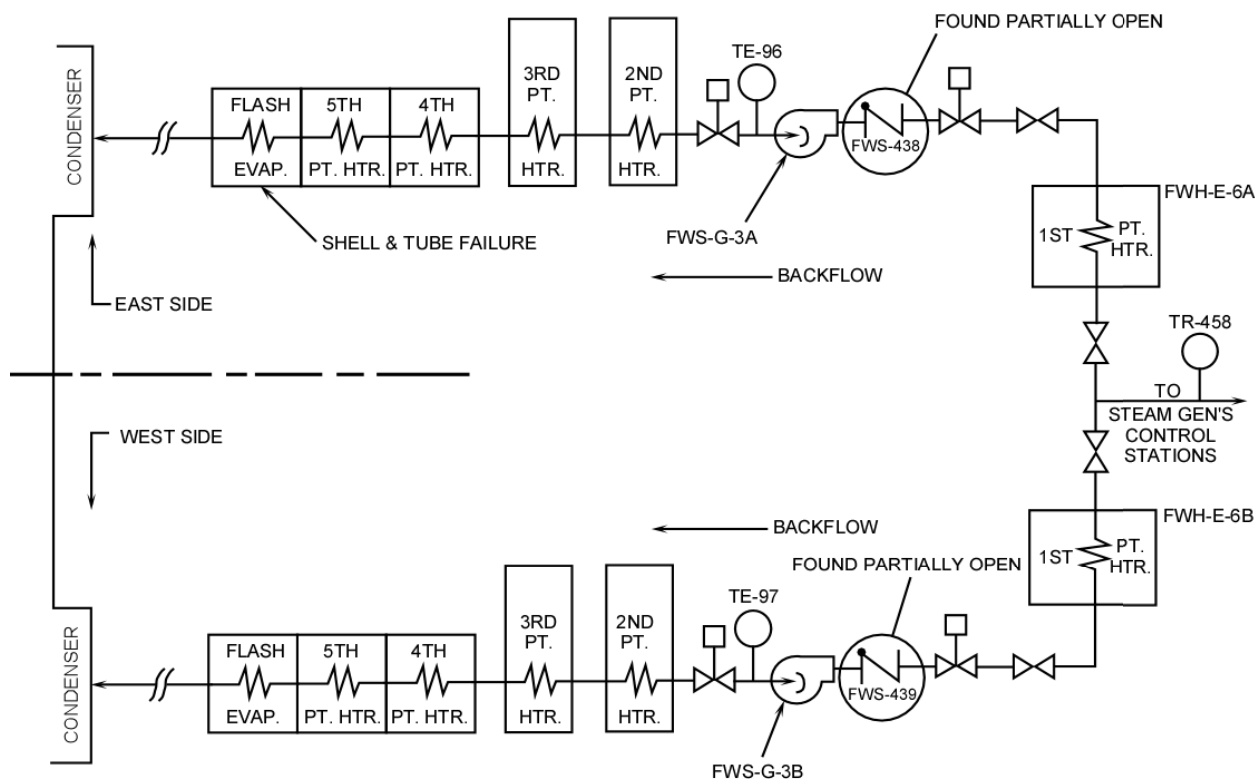
Figure 7.3-6 SONGS-1 Feedwater Flow Diagram

The plant conditions at SONGS-1 which led to a steam condensation-induced water hammer included the voiding of long horizontal lengths of feedwater lines, which allowed the backflow of steam from all steam generators before operators isolated the FW lines (by closing motor-operated valves MOV-20, 21, and 22), and the subsequent refilling of the FW lines with relatively cold (i.e., less than 100°F) AFW. Figures 7.3-3, 7.3-4, 7.3-5, 7.3-6, 7.3-7 and 7.3-8 illustrate the flowpaths, valves and other equipment affected by this water hammer.

The gross failure of upstream check valves, which permitted water to drain from the feedwater lines and be replaced with steam, was the underlying cause for water hammer. Leaky check valves have been previously cited in reports of other water hammer occurrences. Five check valves are known to have been failed during the SONGS-1 event.

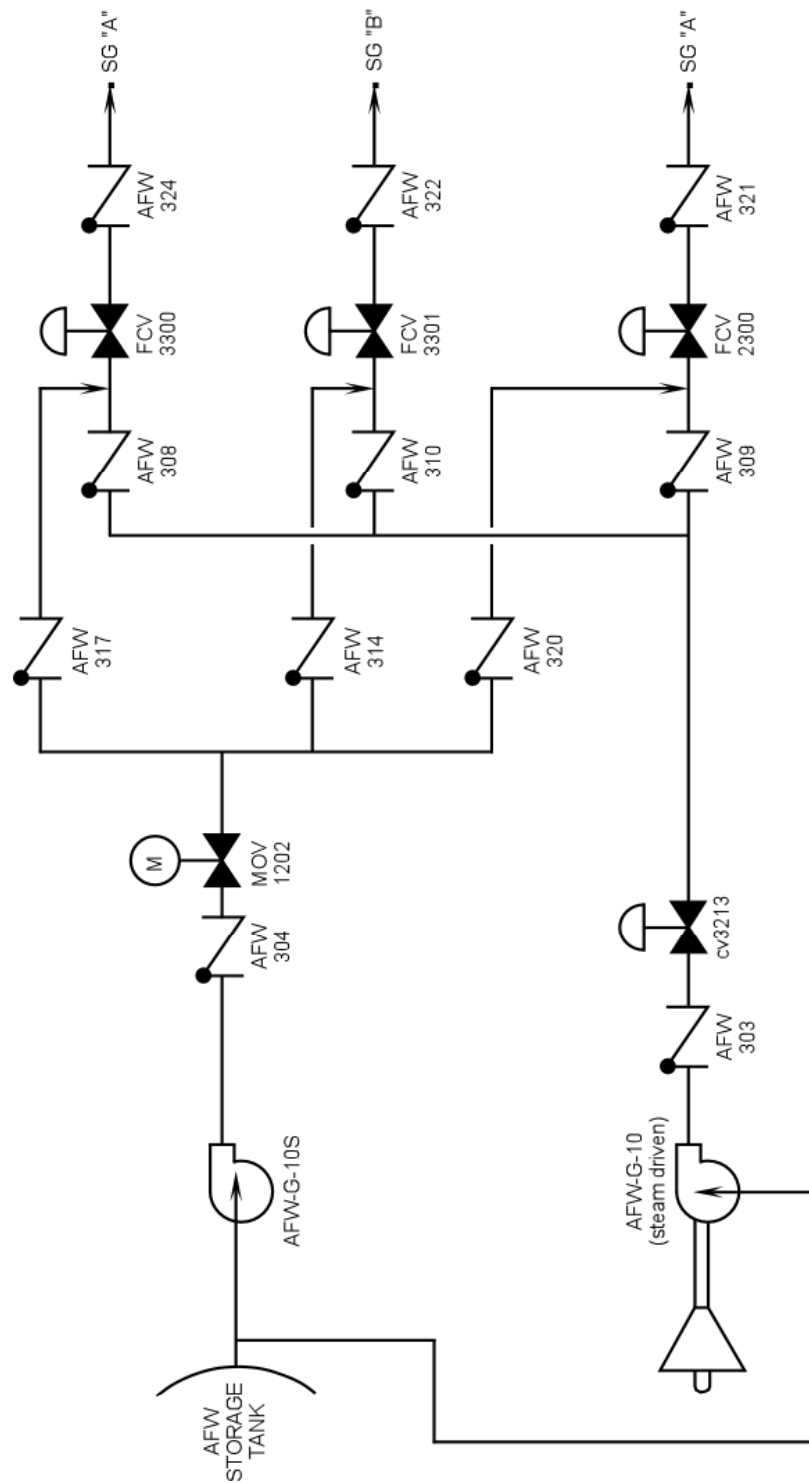
Figure 7.3-8 SONGS-1 Auxiliary Feedwater System

The AFW injection points to the main feedwater piping at SONGS-1 lie in the “breezeway” upstream of the containment building steel shell. The AFW lines run horizontally and then vertically to tie into the main feedwater lines. Water hammer loads were imposed on AFW loop B piping. Although pipe movement extended several hundred feet upstream, there was no evidence of piping damage.

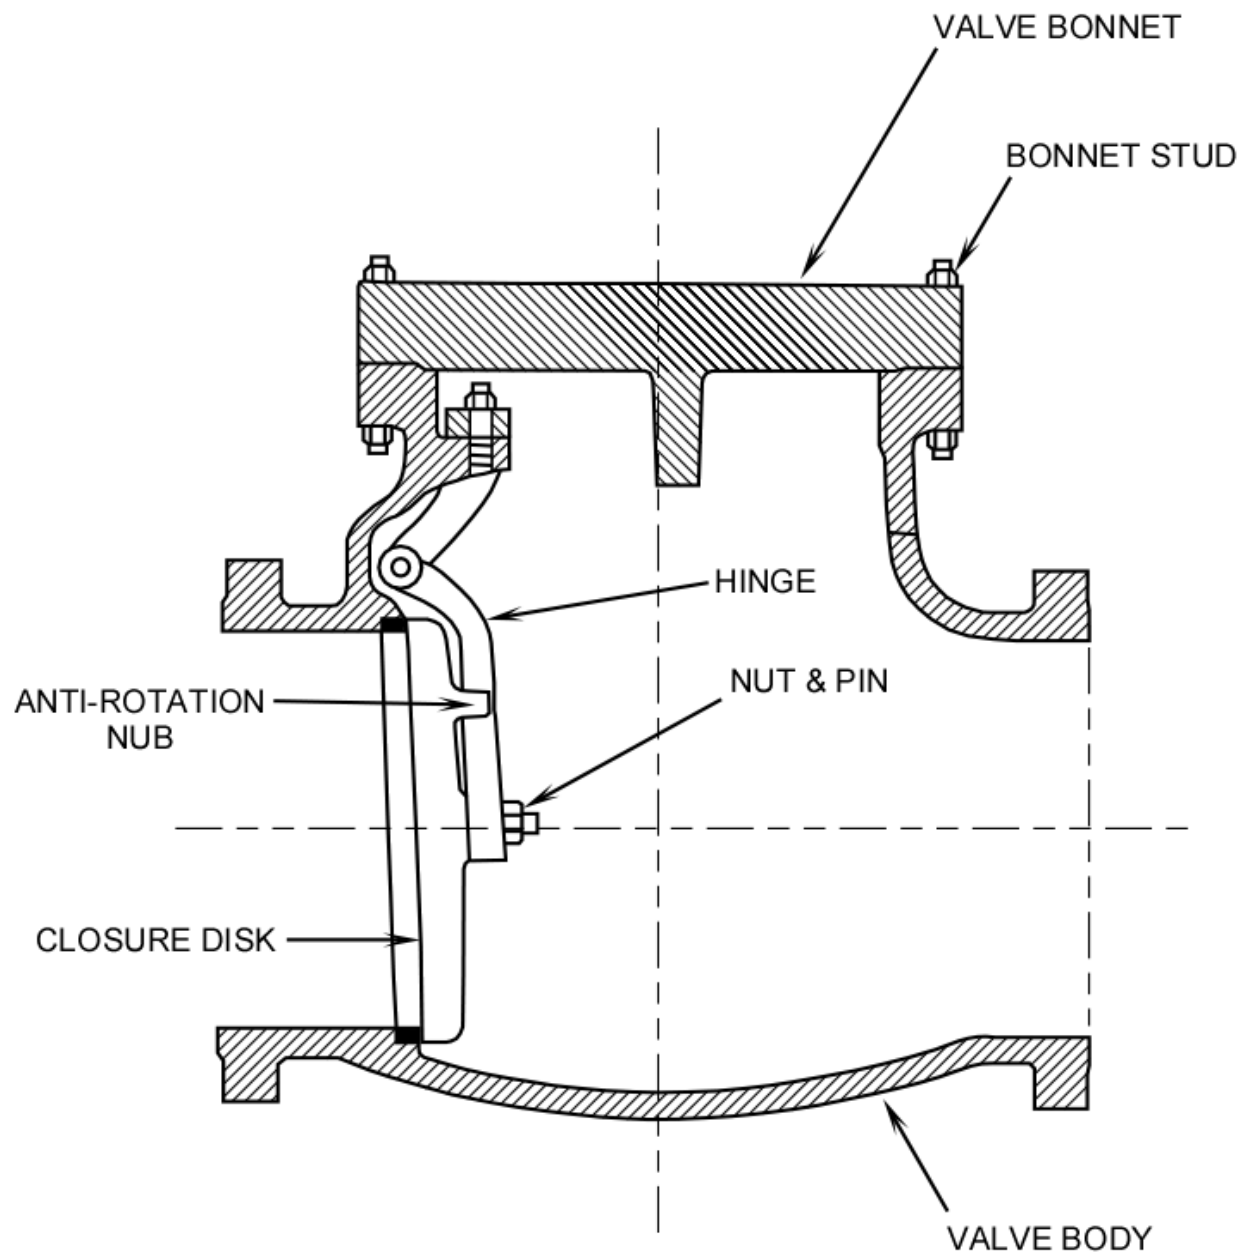
Figure 7.3-11 Typical Swing Check Valve

Figure 7.3-11 shows the typical internal arrangement of a swing check valve. The water hammer originating in the feedwater line within the containment building generated a water slug which transmitted a pressure wave upstream to the loop B flow control station. Check valves FWS-346 and FWS-378, downstream of the control valves, were designed to prevent backflow, although post-event inspection revealed that the closure disk for FWS-346 (see Figure 7.3-12) was lying in the bottom of the valve chamber. Thus, any closed valve upstream of the check valve would be subjected to the water hammer loads. In addition to check valve FWS-378, flow control valve FCV-457 and motor-operated valve MOV-20 were subjected to the water hammer loads, because they had been closed by operators following the emergency operating procedures.

Because check valve FWS-378 was intact and operational, it was subjected to water hammer loads and absorbed much of the water hammer energy, whereupon the bonnet studs yielded and the gasket was forced outward against the studs. The failure of the gasket relieved much of the internal pressure, thereby minimizing damage to other equipment and valves at this station. Valve FCV-457 did incur damage to the flow actuator yoke and a bent valve stem.
